European Association of Geochemistry Photo Contest

Recently, we won the [EAG Photo Contest](#) with a photomicrography entitled *Destructive Beauty*:

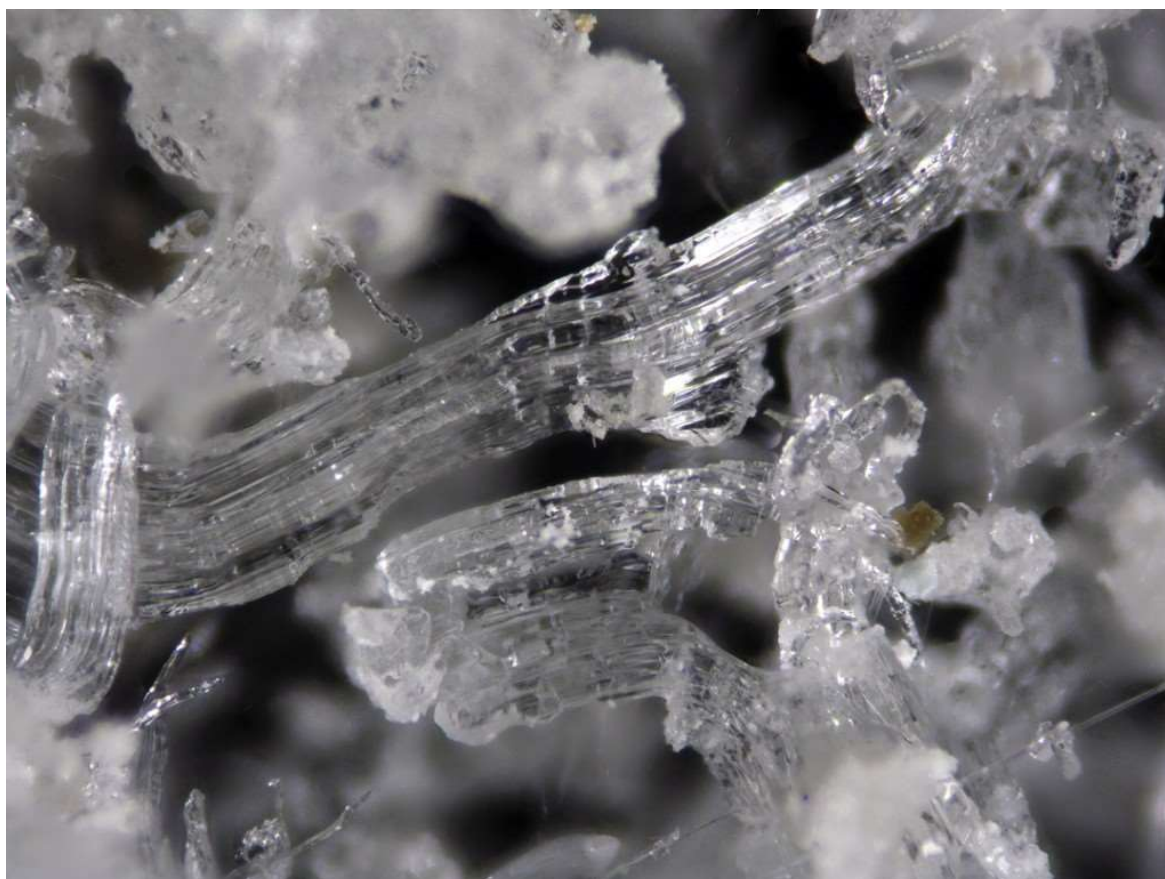
Recently formed Epsomite

The picture shows crystals of neofomed Epsomite (magnesium sulfate heptahydrate) in a wall of my own house, affected by «sulfate attack». The sulfate attack is the alteration process of building materials by rising damp rich in sulfate, usually from the groundwater or materials as plaster. When I closely examined the strong damage that suffered the wall, I observed glittering crystals in the water front that was moving upward by capillarity. As my passions are the photomicrography and the mineralogy, I saw it as an opportunity to understand how the groundwater destroy the building materials and thought that I had caught out *in the act* the process of formation of hydrated secondary phases by weathering of previous materials. Geochemistry in action in my own walls!. The glittering crystals saw promising, and, indeed, under the stereomicroscope showed the beautiful landscape shown in the picture.

As expected, the Raman spectrum of the crystals identified it as Epsomite. The magnesium sulfate reach saturation in the ascending water and forms efflorescences. In this case, the low temperature and stability of conditions favored the crystal growth. The crystallization of Epsomite, a highly hydrated mineral, provokes internal pressure in the materials, swelling, fractures and paint peeling. The Epsomite is not a stable mineral and, with decreasing relative humidity, dehydrates forming Pentahydrate (also identified by Raman spectroscopy), that forms white, pulverulent pseudomorphs after Epsomite. Further dehydration converts the crystals in a white powder. The dehydration lead to shrinking and collapse of the building material.

transformation of materials and formation of new minerals, and the aesthetic impression of the crystals. This is the beauty of Nature, that remind us that all of our creations, civilizations and cultures, futile attempts to transcend, are weak, impermanent and subject to the laws of Geochemistry, that is, the law of constant flow and change. This beauty (conceptual and aesthetic), sometimes hidden to our naked eyes, but always present in Nature and our laboratories, drives my interest in the photomicrography. My routine equipment consist in a Nikon Coolpix camera attached to the phototube of a Zeiss Discovery V8 microscope. The picture is the result of layer composition of 10 frames. Field of view is 2 mm

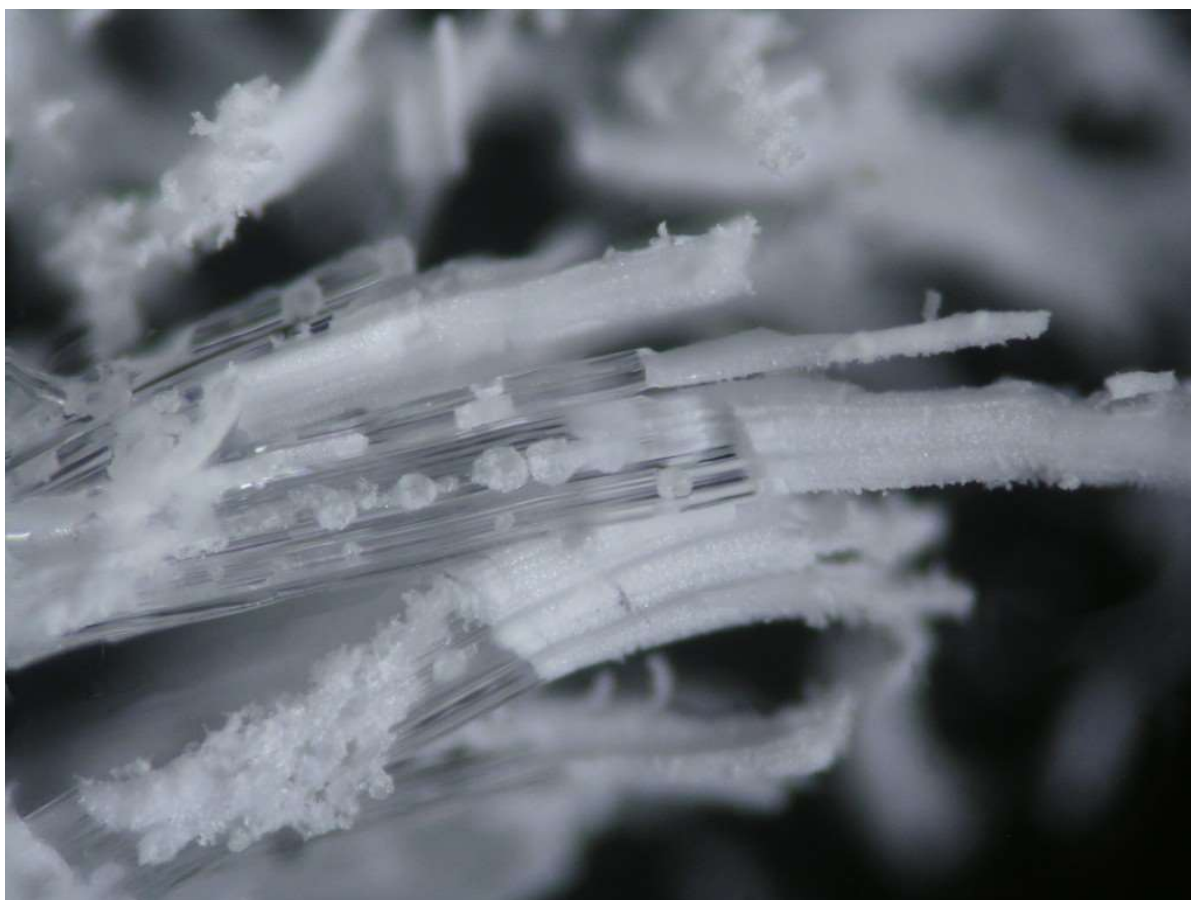
Partially dehydrated epsomite, forming pentahydrate (white)

The saturated sulfate solutions react with materials as concrete, forming other secondary phases. In the picture, thin acicular crystals of Thaumassite (lower right corner) has been identified. The reaction between sulfate rich infiltrating solutions and the calcium silicates and aluminates in the concrete, lead to the formation of Ettringite and Thaumassite, with associated flaking and softening of the concrete and consequent collapse of the structures.
